Project Elijah

Flight Readiness Review Addendum

Cedarville Student Launch 2024-2025

Cedarville University

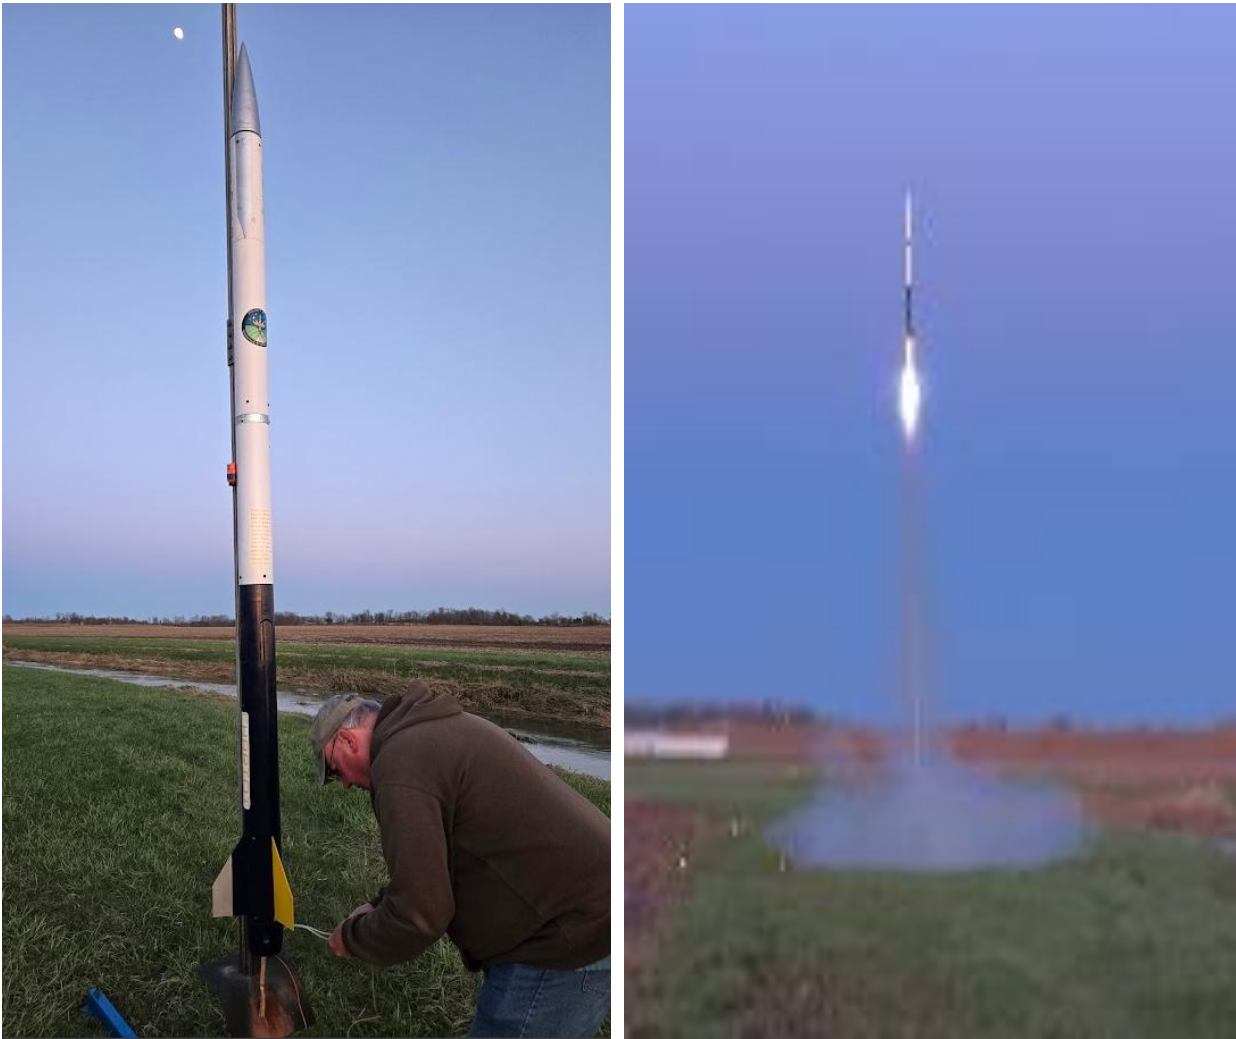
Figure 1.4.1. (Left) CSL's NAR mentor installing the ignitor for Chariot flight #3; (Right) Chariot shortly after rail exit on flight #3.

The third flight of Chariot was conducted on April 8, 2025, and was intended to fulfill the requirements of the Vehicle Demonstration Re-Flight and the Payload Demonstration Flight. Liftoff took place at 8:13 PM for a sunset launch. The rocket was observed to have experienced some wobble and corkscrewing during the motor burn. This was probably due to one of the airbrake flaps not being completely flush with the airframe of the rocket causing some instability during liftoff. A nominal coast phase and recovery sequence was observed with Chariot landing at a speed of 15.5 ft/s, 1317 ft from the launch site 79.6 seconds after launch. The onboard RunCam did not record video of the launch, it stopped recording 47 seconds after being turned on while the rocket was on the launch rail. The reason for the RunCam malfunctioning has not been determined and it has worked as expected in testing both before and after the launch. Tables 1.4.1 and 1.4.2 contain a summary of the relevant information for this flight and Figure 1.4.1 contains Chariot on the launch rail before launch as well as Chariot just after rail exit.

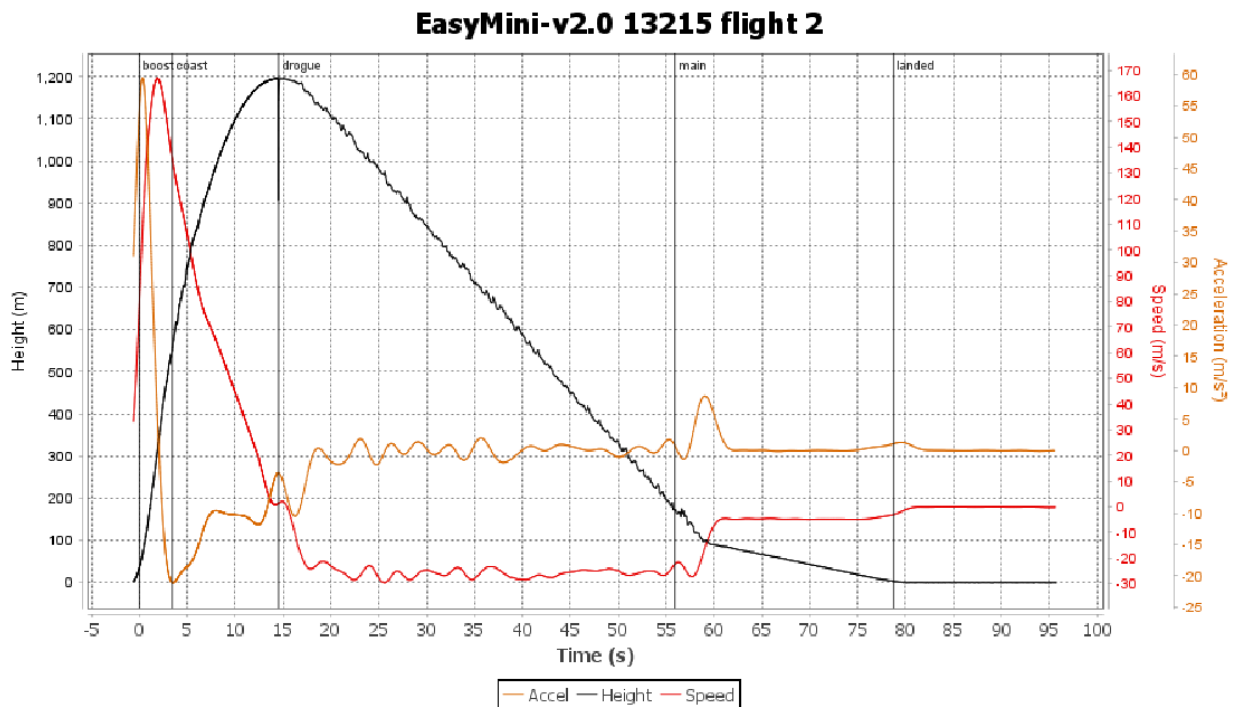
The altimeter flight profile graphs from both the primary RRC3 altimeter and secondary Easy Mini altimeter are shown in Figures 3.3.1 and 3.3.2 respectively. Chariot reached an apogee of 3890 ft as measured by the RRC3 and 3917 ft as measured by the Easy Mini. The landing velocity was found by finding the slope of the altitude vs time during the main parachute descent from the RRC3 altimeter. This landing velocity was calculated to be 15.5 ft/s which is slightly higher than the predicted landing velocity of 14.5 ft/s. All four ejection charges were successfully ignited by the two altimeters and facilitated a nominal recovery sequence.

Figure 3.3.2. Altimeter flight profile graph of Chariot flight #3 from secondary Easy mini altimeter.

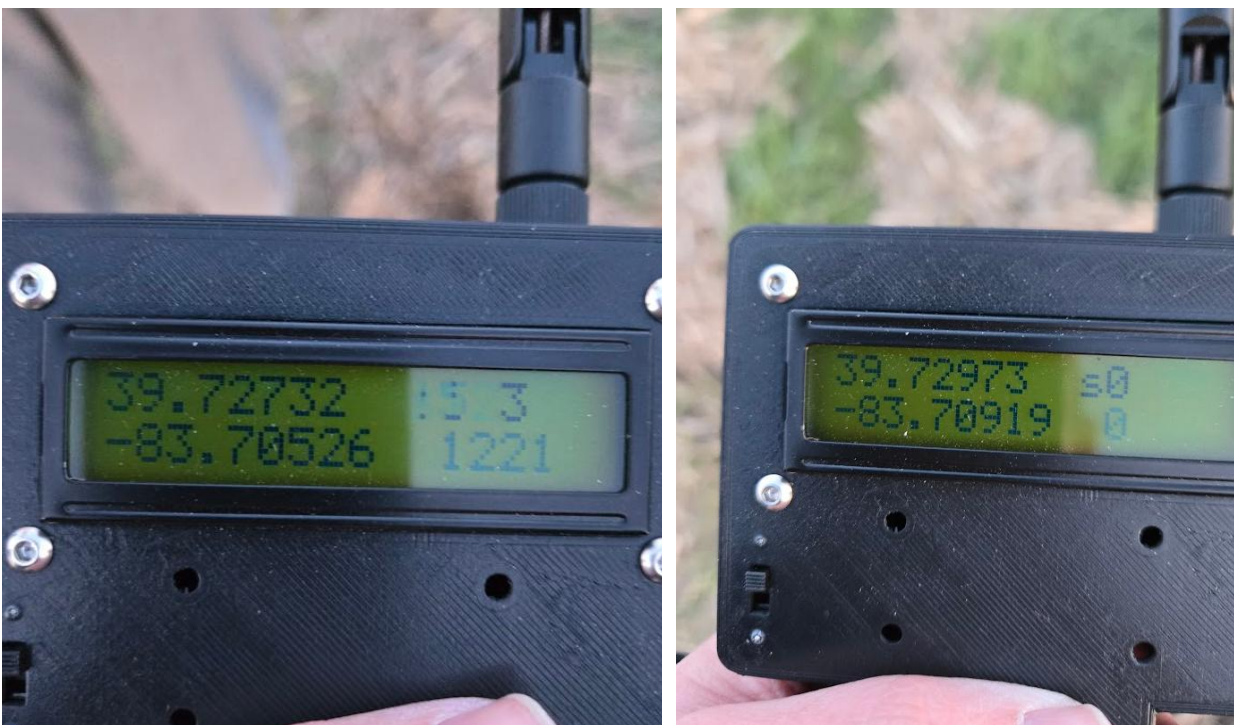
Figure 3.4.2. (Left) Picture of Eggtimer gps reciever while Chariot is on the launch rail. (Right) Eggtimer gps receiver after landing.

Chariot experienced a nominal recovery sequence during this third flight. The rocket landed 1,317 ft southeast of the launch site at a nominal velocity of 15.5 ft/s. Figure 3.4.1 contains an aerial view of the launch and landing sites and Figure 3.4.2 contains pictures of the gps receiver before and after launch verifying that the gps works as designed and transmits the location of chariot to the handheld receiver after the recovery sequence has been completed.

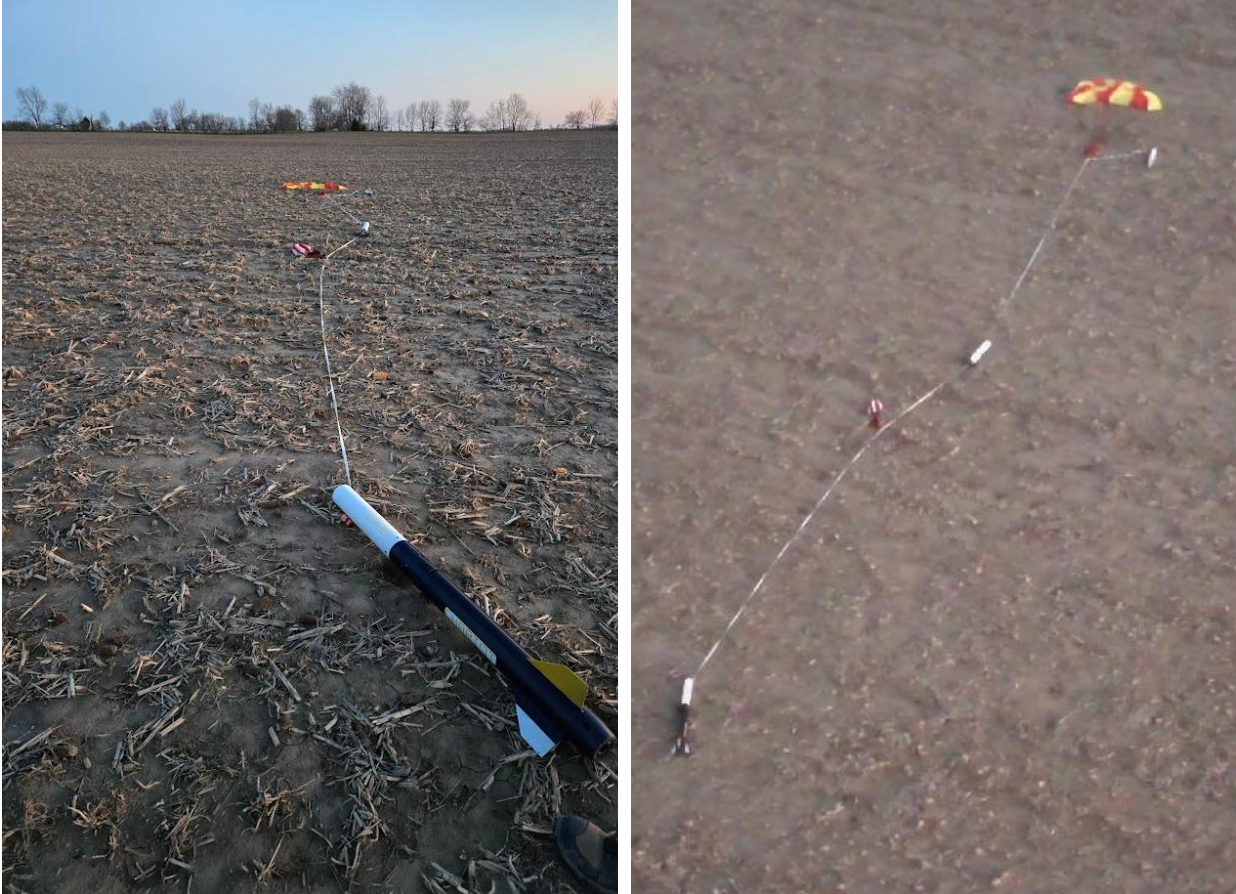
After landing, the aft section of Chariot was dragged along the ground for a few feet by the wind blowing the inflated main parachute as evidenced by an amount of mud being found inside the drogue parachute pay upon recovery. Nevertheless, Chariot sustained no damage during recovery. As landed photos of Chariot are recorded in Figures 3.4.3 through Figure 3.4.something below. Table 3.4.1 contains the actual kinetic energy of each section upon landing.

Figure 3.4.3. As landed configuration of Chariot after flight #3 (drone view on right).

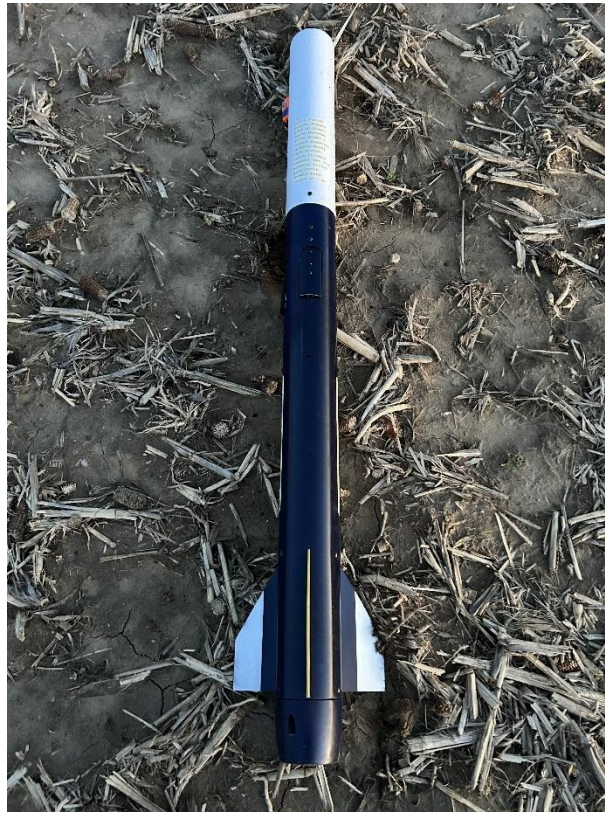
Figure 3.4.4. Chariot aft section as landed configuration.

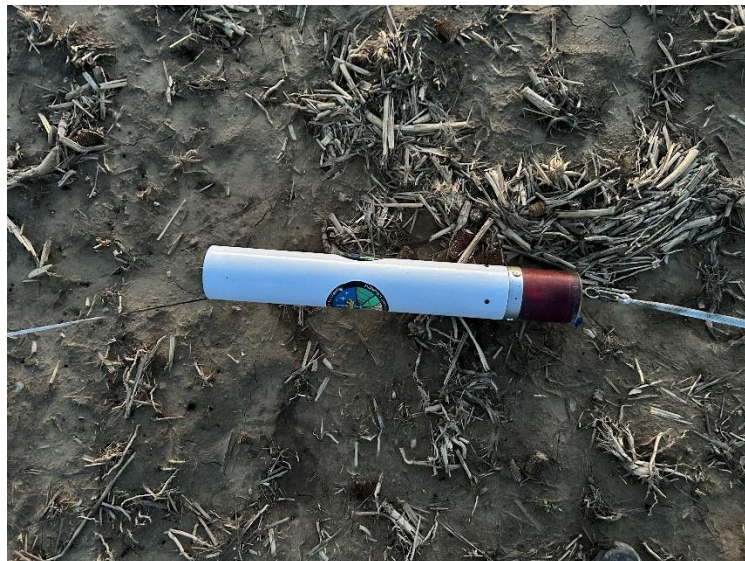
Figure 3.4.5. Chariot avionics section as landed configuration.

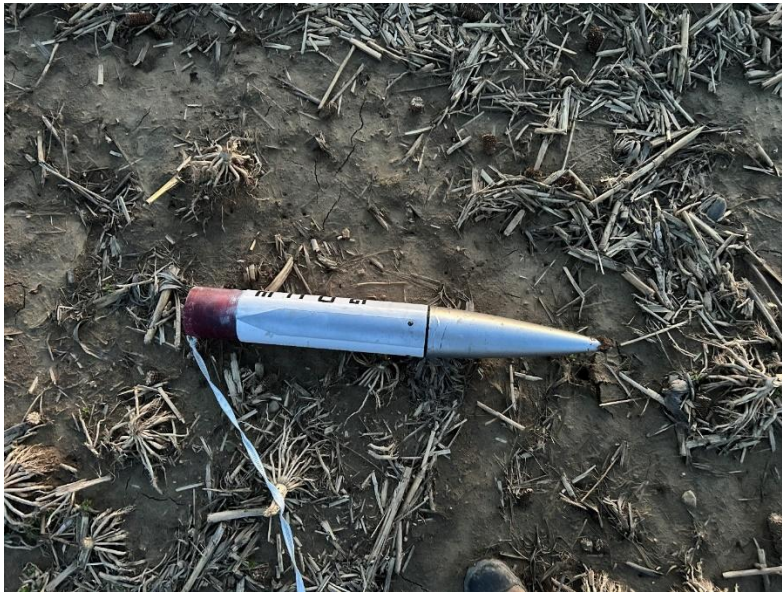
Figure 3.4.6. Chariot forward section as landed configuration.

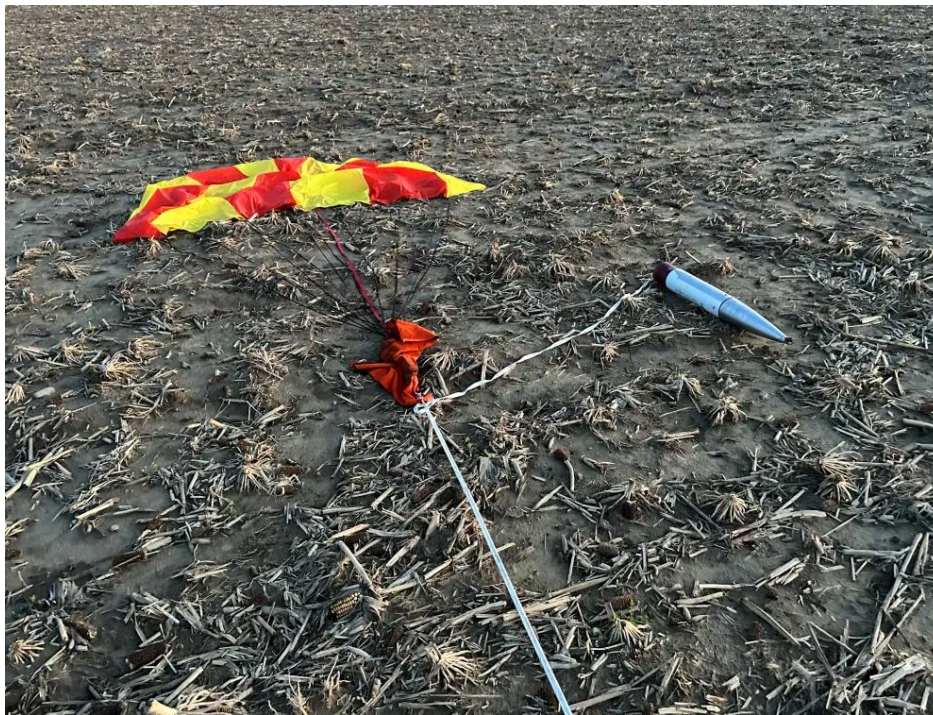
Figure 3.4.7. Chariot forward section and main parachute as landed configuration.
